# Manhole Inspection Summary

Manhole # S21M\_\_018MH

Insp Date: **4/8/08 11:06 AM**

**Location** Address: **1731 cole st**

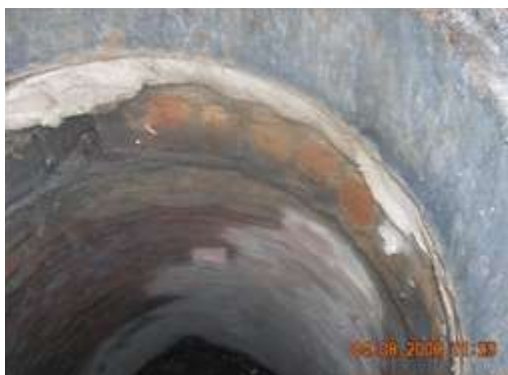
Defect 4

Condition: ☐ Sound ☒ **Cracked** ☐ Root Intrusion ☐ Loose Brick ☒ **Deteriorated**

Infiltration: ☐ None ☒ **Joint** ☐ Cracks ☐ Mortar ☐ Roots ☐ Wall

chimney cracked, deteriorating, infiltration @ chimney joint

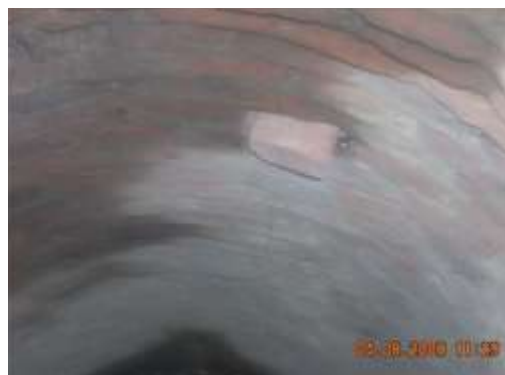
Defect 3

Condition: ☐ Sound ☐ Cracked ☐ Root Intrusion ☒ **Loose Brick** ☐ Deteriorated

loose barrel brick

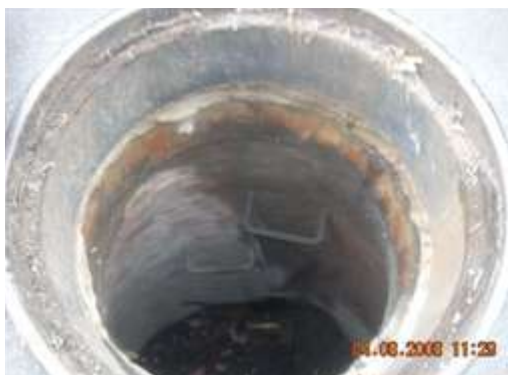
Defect 2

Condition: ☐ Sound ☐ Cracked ☐ Root Intrusion ☐ Deteriorated ☐ Leaks ☒ **Debris**

inflow evidence, channel debris

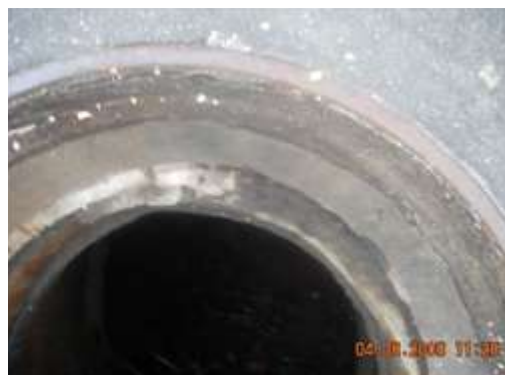
Defect 1

Offset: **1** (in.)

frame offset

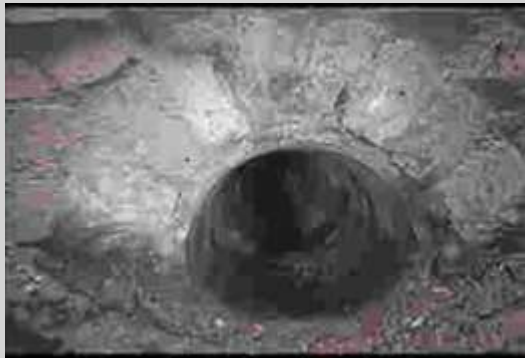
12 O'Clock Outflow

Deposits: ☐ None ☒ **Mud** ☐ Sludge ☐ Debris ☐ Grease

Silt Depth: **1** (in.) Deposits Extent: **Light**
